## **REPORT ON TRAIN DERAILMENT IN PITTSBURGH TUNNEL WEDNESDAY OCTOBER 10, 2001**

**By Thomas Edward Fox**

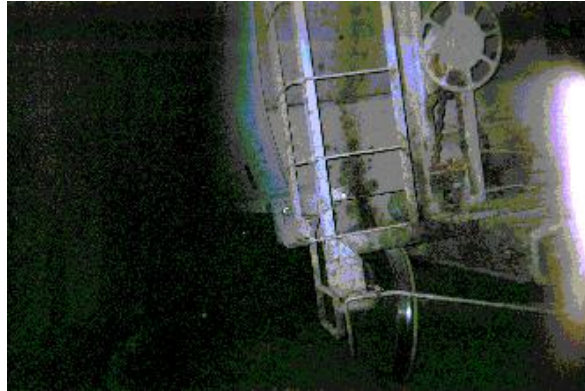
*Derailed Cars in Tunnel*

Twelve derailed hopper cars were left positioned in an “accordion” manner down the tracks in the tunnel and touching the tunnel walls. At least three of the cars were lying on their sides against the walls of the tunnel. Railroad officials decided that all cars should have the grain corn on the cars unloaded before any attempt would be made to right them or pull them out of the tunnel. This tactic of reducing the weight of the cars would hopefully prevent severe damage to the cars, the track bed, and the walls of the tunnel.

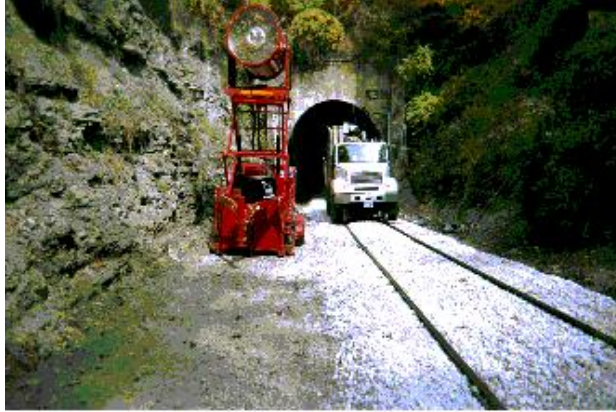
*MVU Positioned in Front of Tunnel Portal*

The MVU was then positioned approximately ninety (90) feet from the south portal of the tunnel. It was placed to the side of the tracks allowing the heavy equipment and other train cars to pass by on the track bed.

The MVU blower was elevated to about 12 feet above the track bed and turned approximately twenty degrees toward the portal. It was tilted downward toward the opening at approximately a fifteen-degree angle. An “air lock seal” was formed around the “mouth” of the tunnel, which prevented the pressurized air in the tunnel from escaping through the entry portal. (A note was made that had there been no space for the MVU along the side of the tracks - solid rock face for example, a “platform” could have been built on the ravine wall and the MVU could have been aimed downward from this greater angle to ventilate the tunnel opening.)

The initial readings of air movement at, and in, the tunnel were zero velocity. When the MVU was cranked and the engine accelerated to approximately 2400 RPM, the air velocity in the portal was measured at 18.1mph. This measurement was taken from the center of the track bed and eight feet above the ground (as high as the anemometer could be held in the hand above the head).

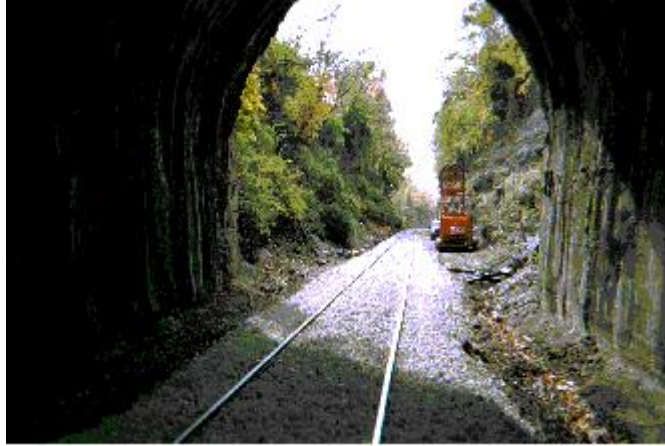
*View From Inside Tunnel of MVU*

At the same 8' height and center of the track bed but at 40' into the tunnel, the wind speed was measured at 11mph. Measurements at 60' into the tunnel were recorded at 8.5mph, at 80' wind speed was 7mph, and at 100' the wind velocity was 5.6mph.
