REPORT ON TRAIN DERAILMENT IN PITTSBURGH TUNNEL WEDNESDAY OCTOBER 10, 2001

By Thomas Edward Fox

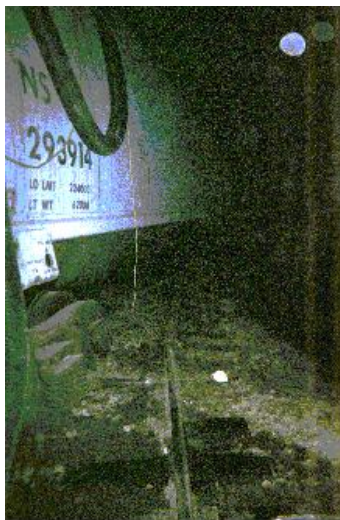
Derailed Cars in Tunnel

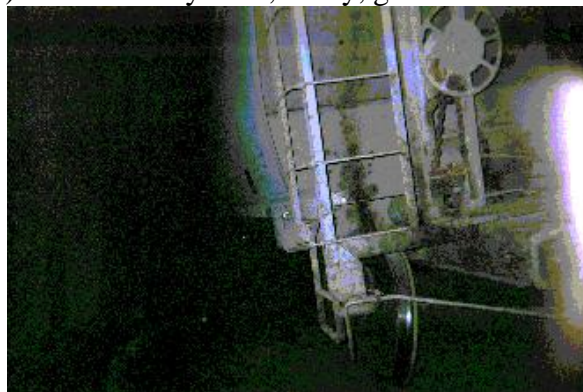
Derailed Cars in Tunnel

Twelve derailed hopper cars were left positioned in an “accordion” manner down the tracks in the tunnel and touching the tunnel walls. At least three of the cars were lying on their sides against the walls of the tunnel. Railroad officials decided that all cars should have the grain corn on the cars unloaded before any attempt would be made to right them or pull them out of the tunnel. This tactic of reducing the weight of the cars would hopefully prevent severe damage to the cars, the track bed, and the walls of the tunnel.

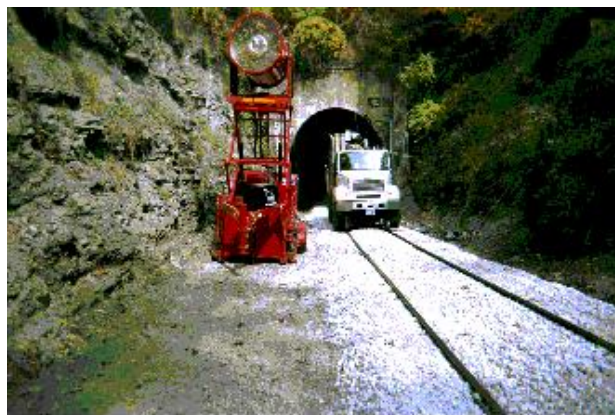
MVU Positioned in Front of Tunnel Portal

The MVU was then positioned approximately ninety (90) feet from the south portal of the tunnel. It was placed to the side of the tracks allowing the heavy equipment and other train cars to pass by on the track bed.

The MVU blower was elevated to about 12 feet above the track bed and turned approximately twenty degrees toward the portal. It was tilted downward toward the opening at approximately a fifteen-degree angle. An “air lock seal” was formed around the “mouth” of the tunnel, which prevented the pressurized air in the tunnel from escaping through the entry portal. (A note was made that had there been no space for the MVU along the side of the tracks - solid rock face for example, a “platform” could have been built on the ravine wall and the MVU could have been aimed downward from this greater angle to ventilate the tunnel opening.)

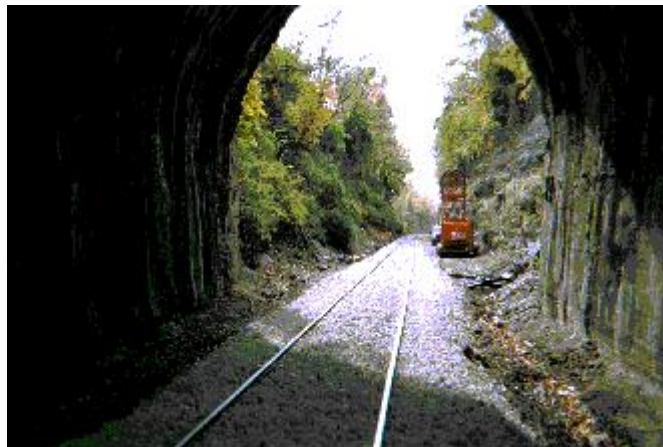
View From Inside Tunnel of MVU

At the same 8' height and center of the track bed but at 40' into the tunnel, the wind speed was measured at 11mph. Measurements at 60' into the tunnel were recorded at 8.5mph, at 80' wind speed was 7mph, and at 100' the wind velocity was 5.6mph.

The initial readings of air movement at, and in, the tunnel were zero velocity. When the MVU was cranked and the engine accelerated to approximately 2400 RPM, the air velocity in the portal was measured at 18.1mph. This measurement was taken from the center of the track bed and eight feet above the ground (as high as the anemometer could be held in the hand above the head).
